## AIRWORTHINESS DIRECTIVE

No. 2026-МИ-8,171-05

Applicability Mi-8MTV-1, Mi-8AMT, Mi-171, Mi-172, Mi-171A, Mi-171A2, Mi-171A3  
type Helicopters and their Modifications  
State of Designer – Russian Federation

## TECHNICAL SOLUTION No. HCB-KB-1.2-3ЧУ(2ПУ)-2026

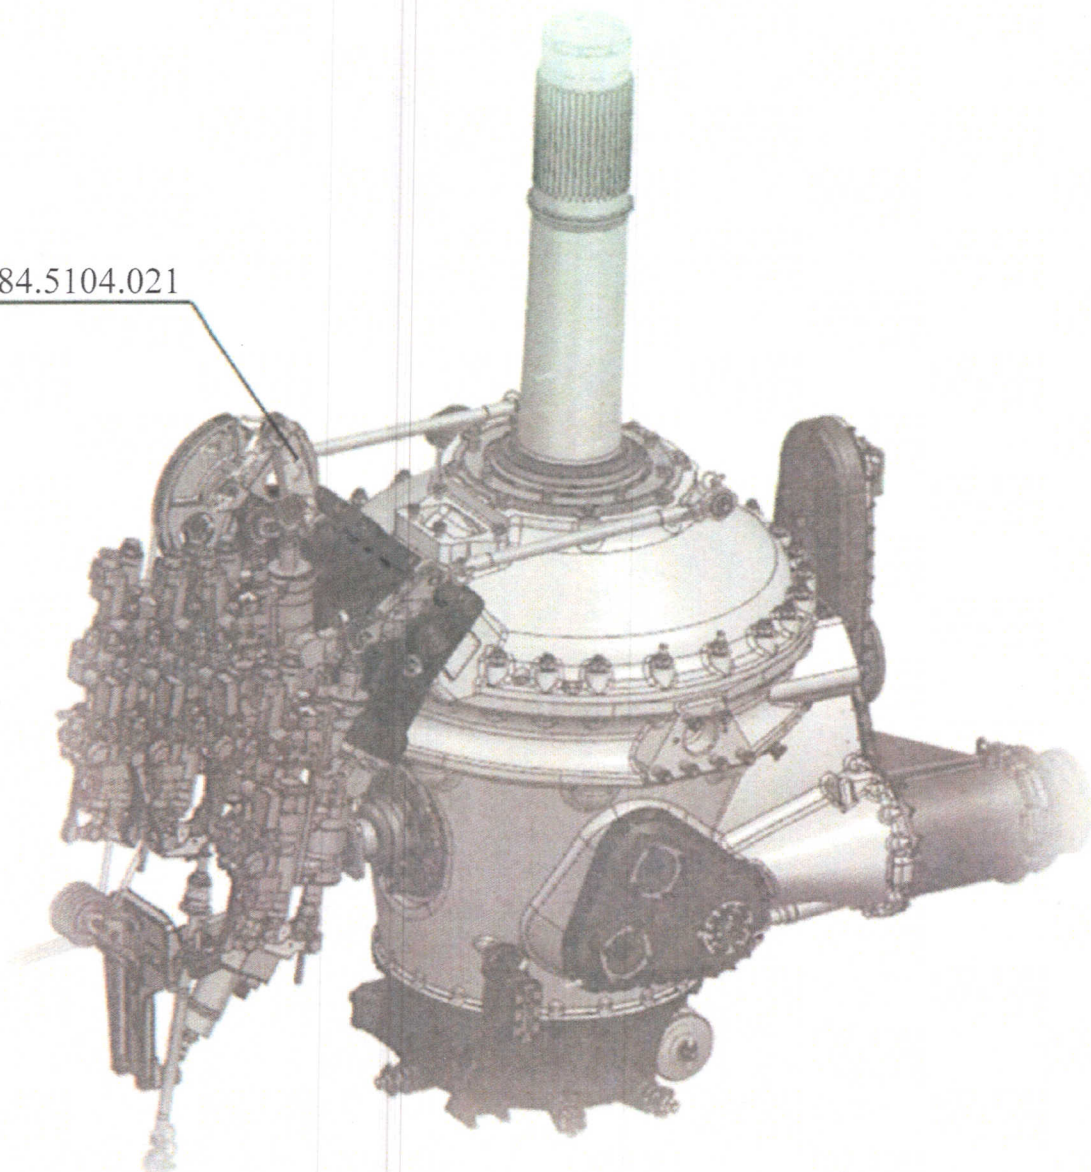
1. For organizations operating the helicopters to perform an inspection every  $25 \pm 5$  flight hours of the **condition of the directional control bellcrank 184.5104.021 (Fig.1) for cracks, cracked surface or damaged paint and varnish coating as well as dents.**

**Fig.1 – Directional control bellcrank 184.5104.021 position.**

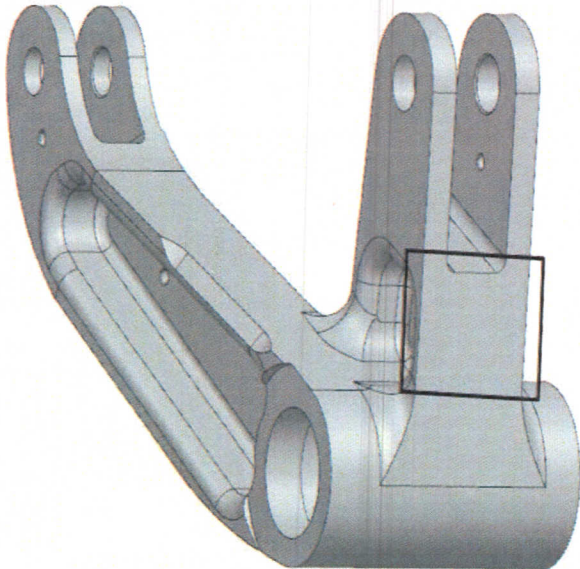
| <p>1. Place stepladder, open the cowl doors of engine, gearbox, APU sections, unscrew attachment bolts and remove upper cowls of the gearbox section.</p> <p>2. Using a spherical mirror or sevenfold magnifying glass inspect Directional Control Bellcrank 184.5104.021 in the actuating portion of control system. Wipe the area to be inspected with a cloth moistened in gasoline. Check the factory marking. Cracks and dents on the bellcrank are not tolerated. If paint and varnish coating is damaged (cracked surface) in the areas marked in Fig.1 and Fig.2, remove the bellcrank from operation and notify Helicopters Mil and Kamov, JSC</p> | | <p>When the bellcrank defects are detected, remove the bellcrank from operation, take the supporting photos and notify Helicopters Mil and Kamov, JSC.</p> |

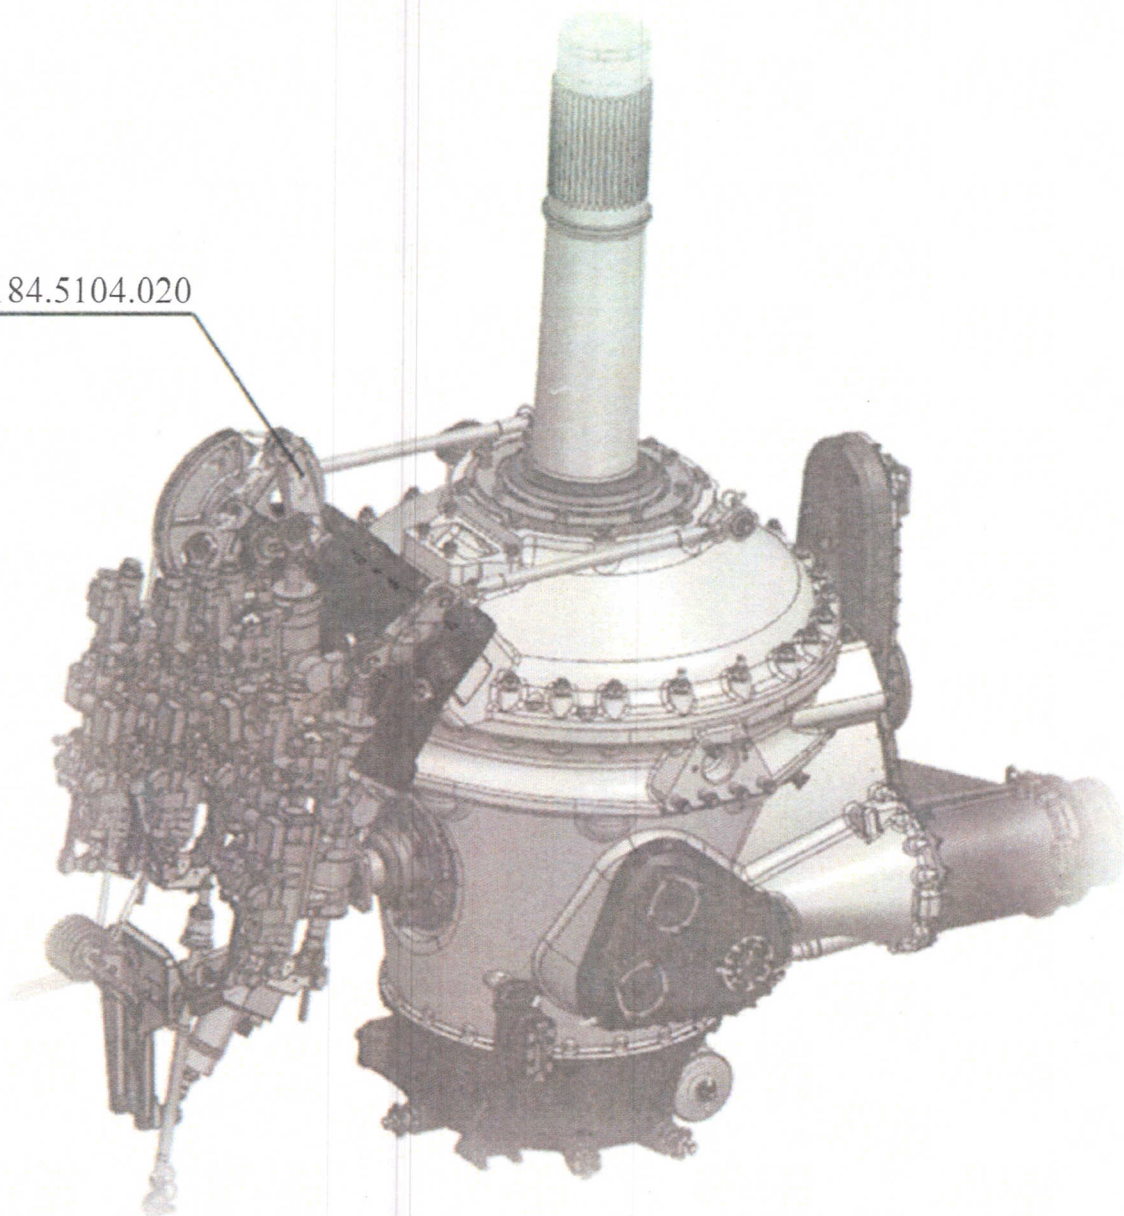
1. For organizations operating and providing maintenance to the helicopters to demount the directional control bellcranks **184.5104.020 (assembly unit composed of bellcrank 184.5104.021 with bushings and bearings)** of batch no. H<sub>3</sub>06, H<sub>3</sub>10, H<sub>3</sub>15, H<sub>3</sub>18, H<sub>3</sub>19, H<sub>3</sub>22, H<sub>3</sub>23, H<sub>3</sub>26, H<sub>3</sub>27, H<sub>3</sub>29, H<sub>3</sub>30, H<sub>3</sub>32, H<sub>3</sub>35, H<sub>3</sub>37, H<sub>3</sub>41, H<sub>3</sub>44, H<sub>3</sub>47, H<sub>3</sub>48, H<sub>3</sub>50 and replace with the bellcranks of the first category.

**Fig.1 – Directional control bellcrank 184.5104.020 position.**

2. It is forbidden to operate the helicopters with the bellcranks 184.5104.021 of batch no. H<sub>3</sub>06, H<sub>3</sub>10, H<sub>3</sub>15, H<sub>3</sub>18, H<sub>3</sub>19, H<sub>3</sub>22, H<sub>3</sub>23, H<sub>3</sub>26, H<sub>3</sub>27, H<sub>3</sub>29, H<sub>3</sub>30, H<sub>3</sub>32, H<sub>3</sub>35, H<sub>3</sub>37, H<sub>3</sub>41, H<sub>3</sub>44, H<sub>3</sub>47, H<sub>3</sub>48, H<sub>3</sub>50.
